Enclosed is the report for the compliance inspection conducted at Cottage Hill Farm on May 22, 2012. A copy of this report is being forwarded to the U.S. Environmental Protection Agency, Region III.

EPA Water Compliance Inspection Report

Name and Location of Facility Inspected:	<u>Cottage Hill Farm</u> <div style="background-color: black; width: 100px; height: 15px; margin: 2px 0;"></div> <u>Petersburg, WV 26847</u> <u>Grant County, WV</u>	Entry Time: <u>8:55 a.m.</u>	Permit Effective Date: <u>N/A</u>
Name(s) of On-Site Representatives(s) Titles/Phone and Fax Numbers:	<div style="background-color: black; width: 100px; height: 30px; margin: 2px 0;"></div>	Exit Time/Date: <u>11:49 a.m. / 05/22/2012</u>	Permit Expiration Date: <u>N/A</u>
Name, Address of Responsible Official/Title/Phone/Fax:	<div style="background-color: black; width: 100px; height: 30px; margin: 2px 0;"></div>	Contacted: Yes <input checked="" type="checkbox"/> No <input type="checkbox"/>	Other Facility Data: <u>N/A</u>

**WEST VIRGINIA DEPARTMENT OF ENVIRONMENTAL PROTECTION
WV/NPDES CONCENTRATED ANIMAL FEEDING OPERATION PERMIT
INSPECTION REPORT FORM**

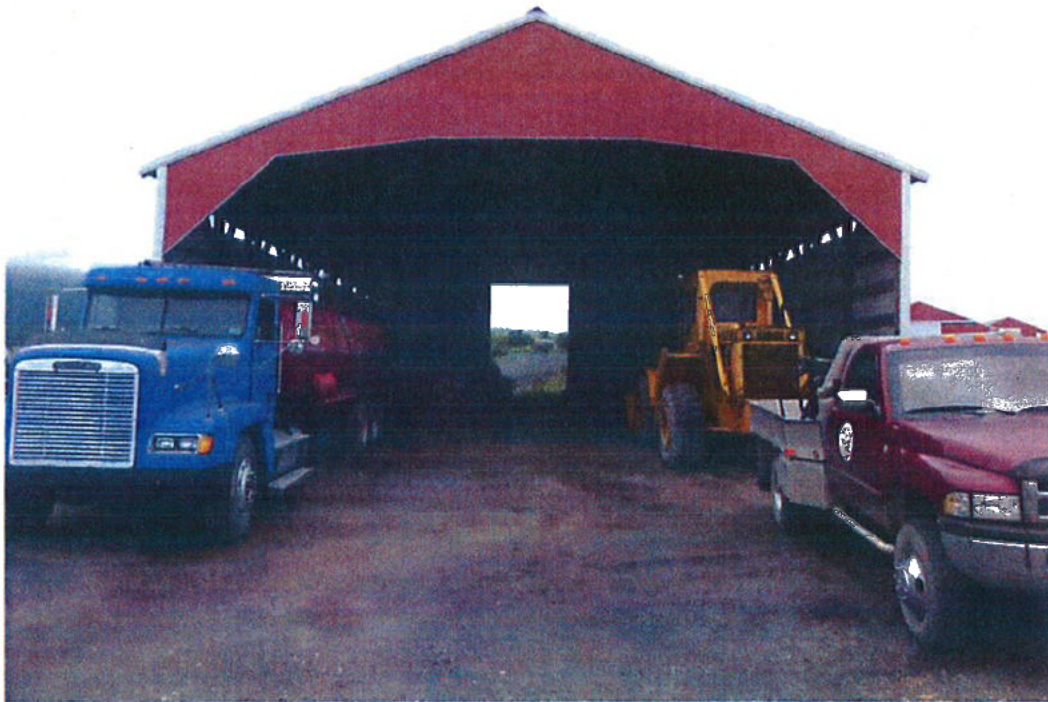
Photo Reference	Photo Filename	Description
Photo 1	DSCN1255	South end of Litter Shed
Photo 2	DSCN1256	South end of House 6
Photo 3	DSCN1257	South end of House 5
Photo 4	DSCN1258	East side of House 5
Photo 5	DSCN1259	Culvert leading to hay field behind Litter Shed
Photo 6	DSCN1260	Accidental photo
Photo 7	DSCN1261	Heating unit on east side of House 6
Photo 8	DSCN1262	Culvert pipe at north end of House 6
Photo 9	DSCN1263	Culvert pipe at north end of House 5
Photo 10	DSCN1264	Unnamed tributary to north end of Houses
Photo 11	DSCN1265	Unnamed tributary to north of Houses continuing west
Photo 12	DSCN1266	North end of House 1
Photo 13	DSCN1267	North end of House 2
Photo 14	DSCN1268	Eroded area where culvert pipe is located to north of Houses 1 and 2
Photo 15	DSCN1269	Houses 1 and 2 culvert pipe
Photo 16	DSCN1270	Houses 2 and 3 culvert pipe
Photo 17	DSCN1271	Area where culvert pipe from Houses 2 and 3 discharges

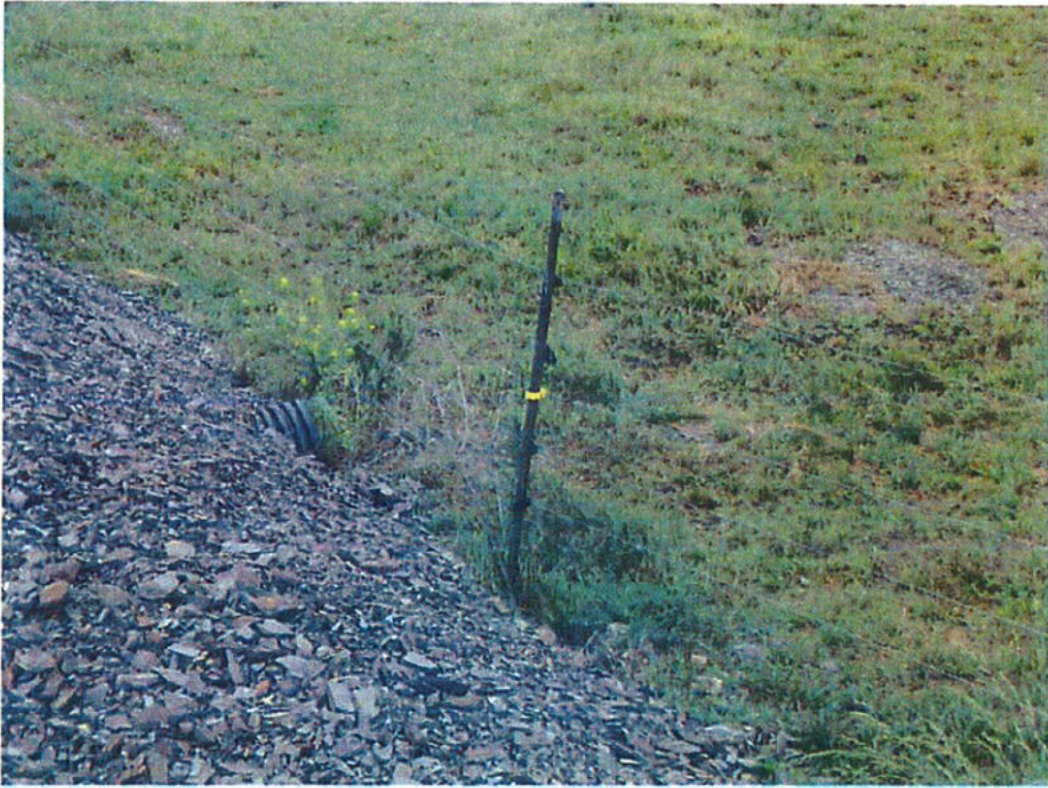
Photo 5

- Stormwater flow from the south half of all houses, litter shed, and compost shed flowed to the south. Stormwater runoff in this direction all flowed into a hay field and did not have a direct conveyance to waters of the state. Stormwater flow from the north half of all houses flowed to the north. Stormwater runoff in this direction all flowed into an unnamed tributary to Hoglan Run. There were culverts conveying runoff from the poultry facility, north, directly to the unnamed tributary (See photos 8, 9, 10, 11, 14, 15, 16, 17, 20, 21, 25, and 26). It is at these points where the facility discharges into waters of the State.

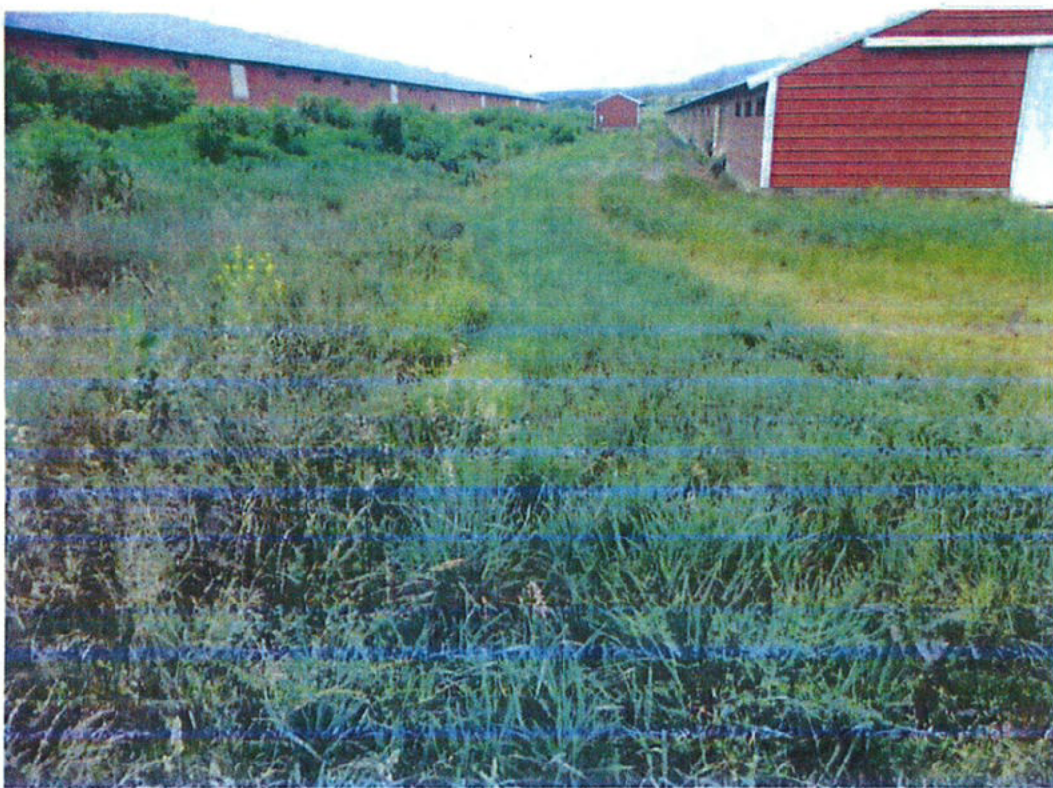
Photo 18	DSCN1272	Ditch line between Houses 2 and 3
Photo 19	DSCN1273	Accidental photo
Photo 20	DSCN1274	Houses 3 and 4 culvert pipe
Photo 21	DSCN1275	Area where culvert pipe from Houses 3 and 4 discharges
Photo 22	DSCN1276	North end of House 3
Photo 23	DSCN1277	North end of House 4
Photo 24	DSCN1278	Accidental photo
Photo 25	DSCN1279	Drainage to north end of House 4
Photo 26	DSCN1280	Unnamed tributary above poultry facility flowing to House 4 discharge
Photo 27	DSCN1281	West side of House 4
Photo 28	DSCN1282	North end of Compost Shed
Photo 29	DSCN1283	South end of Compost Shed
Photo 30	DSCN1284	Entrance Sign
